UI Board Test & Trouble Shooting

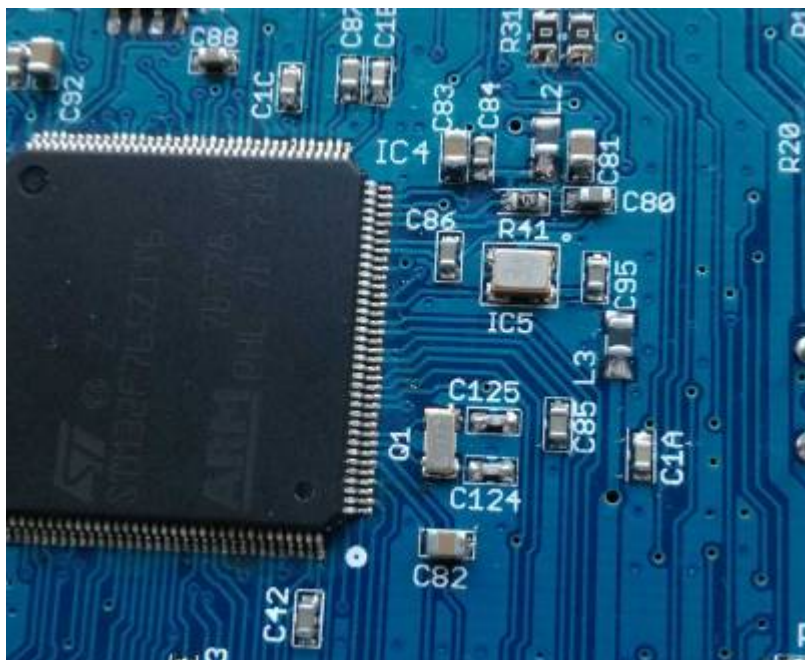
Attention: STM32 MCU Pin1 Mark

The MCU seems to have two (!) pin 1 marks. Watch text orientation on MCU to find „real“ pin 1.

Orientation of TXCO & MCU (photo DF9EH)

- RTC clock crystal and TXCO are prerequisite for flash programming to work
- Check correct orientation of TXCO (see photo on this page)
- Check 3.3V at C95. If not present then L3 may be defective

First check that MCU is soldered in in correct orientation (see above „Pin 1“).
