UHSDR Troubleshooting

From: <https://amateurfunk-sulingen.de/wiki/> - Afu - Wiki des DARC OV Sulingen I40

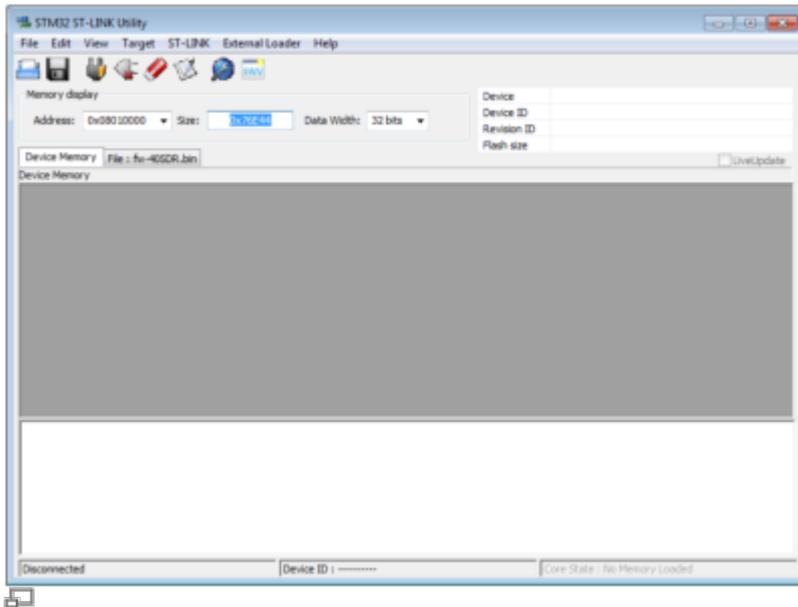
2. ST-Link/V2 Firmware update Procedure

- Connect ST-Link/V2 with PC via USB cable
- SW Utility: ST-Link→Firmware update
- Check on PC screen in status messages that MCU is recognized correctly

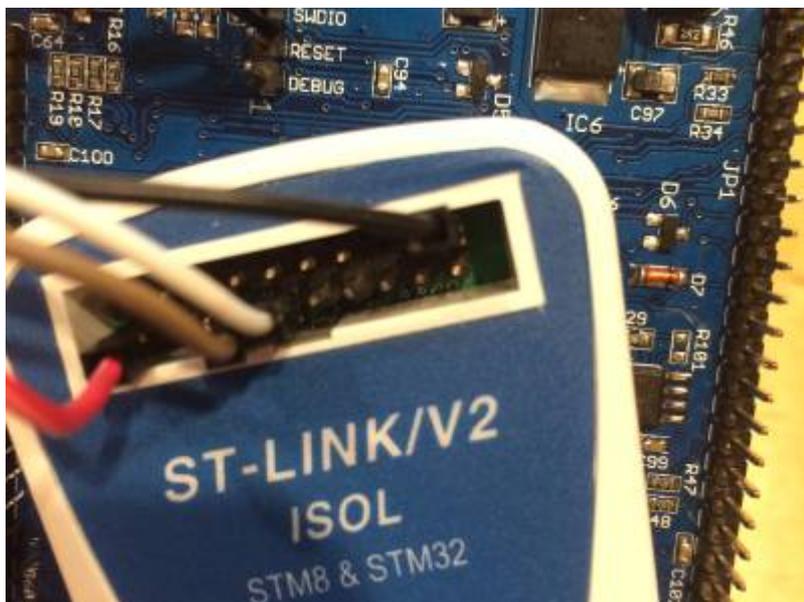
The debug cable shouldn't be longer than 10 cm. 3 to 4 connections are needed.

ST-link adapter	OVI40 UI JP8	
Pin-13 TRACESWO	JP8 Pin 1	Debug Output
Pin-15 NRST	JP8 Pin 2	Reset
Pin-07 SWDIO	JP8 Pin 3	Debug I/O
Pin-09 SWCLK	JP8 Pin 4	Debug Clock
Pin-01 MCU VDD	JP8 Pin 5	VDD from MCU
Pin-20 Gnd	JP8 Pin 6	Ground

Connection ST-Link to UI board (photo F4HTX)

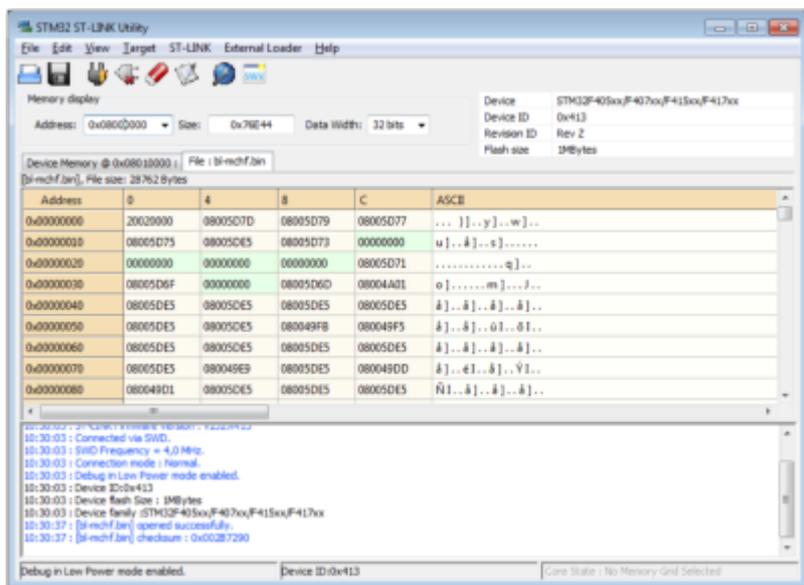
- SW Utility: Target→Connect
- SW Utility: File → Open (select the right .bin file, see above). The following screen should appear: (example shows mchF boot loader)

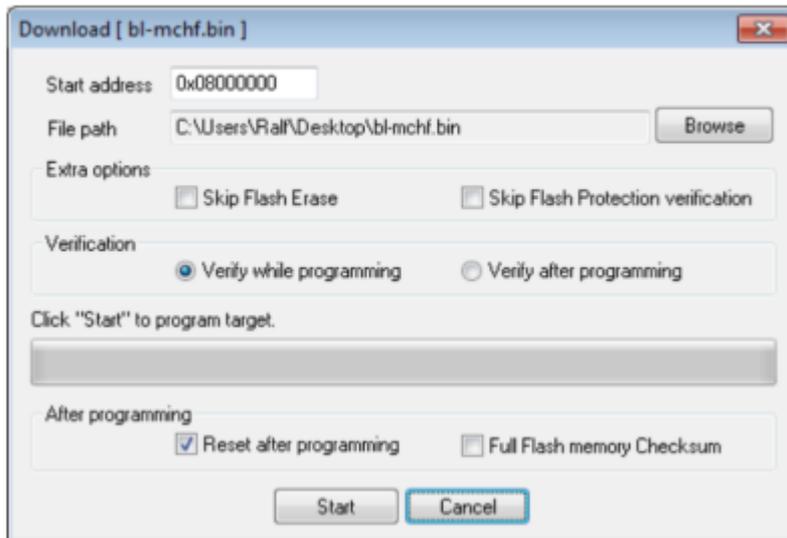
- Write the .bin file onto MCU with Target → Program & Verify
- In the subsequent windo enter start address:
 - start adresse for boot loader: 0x08000000
- Then hit start button to program MCU

Für den Bootloader: 0x08000000

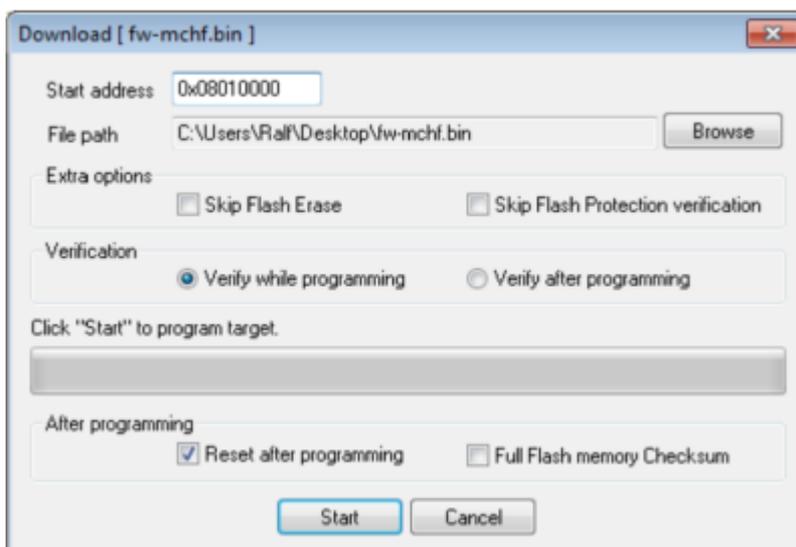
- Then program firmware in the same manner.
 - start address for firm ware would be 0x08010000
