UHSDR Troubleshooting

LCD constant white screen

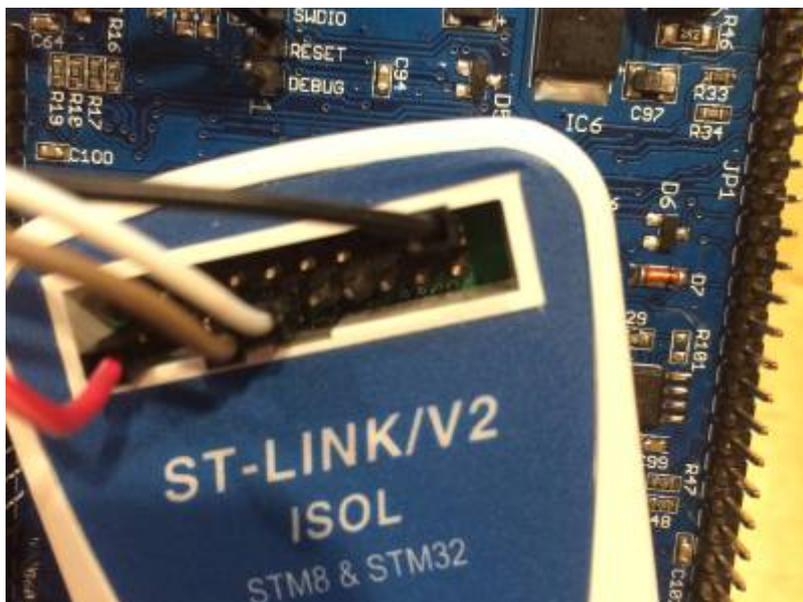
The debug cable shouldn't be longer than 10 cm. 3 to 4 connections are needed.

ST-link adapter	OVI40 UI JP8	Remark
Pin-13 TRACESWO	JP8 Pin 1	Debug Output
Pin-15 NRST	JP8 Pin 2	Reset
Pin-07 SWDIO	JP8 Pin 3	Debug I/O
Pin-09 SWCLK	JP8 Pin 4	Debug Clock
Pin-01 MCU VDD	JP8 Pin 5	VDD from MCU
Pin-20 Gnd	JP8 Pin 6	Ground

Connection ST-Link to UI board (photo F4HTX)

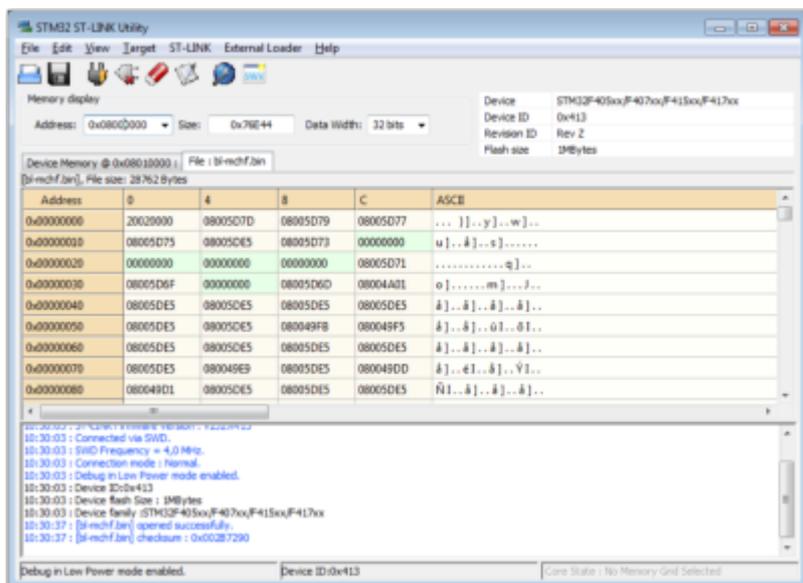
- SW Utility: Target→Connect
- SW Utility: File → Open (select the right .bin file, see above). The following screen should appear: (example shows mchF boot loader)
