## UI Board Test & Fehlersuche

ovi40test:uiboardtest <https://amateurfunk-sulingen.de/wiki/doku.php?id=ovi40test:uiboardtest&rev=1516349754>

<https://amateurfunk-sulingen.de/wiki/> - **Afu - Wiki des DARC OV Sulingen I40**

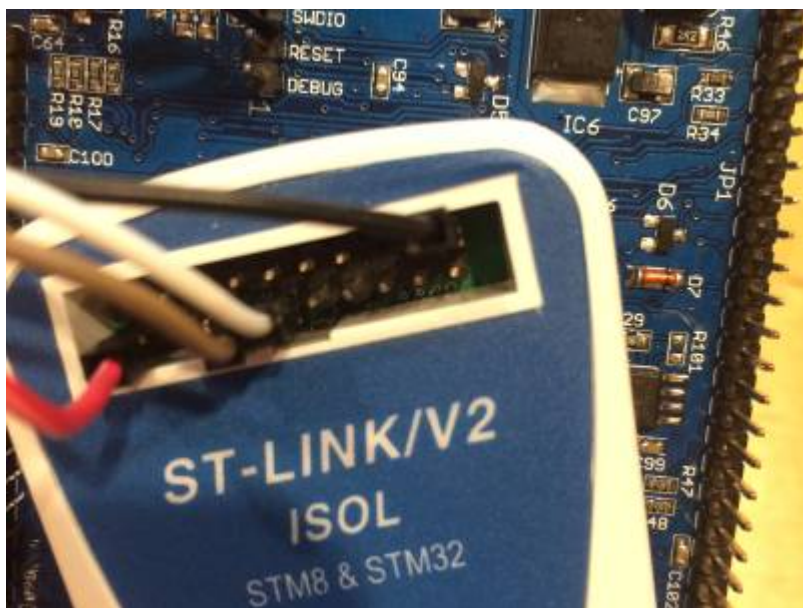
JP8-3 (SWDIO) to JTAG-7 JP8-4 (SWCLK) to JTAG-9 JP8-5 (UI\_3V3) to JTAG-1 JP8-6 (GND) to JTAG-20

ST-Link connection to UI board (Photo F4HTX)

The only tricky part is to connect the probe JTAP connector to the JP8 UI board, here are the needed wires :
