UHSDR Troubleshooting

MCU "bricked"

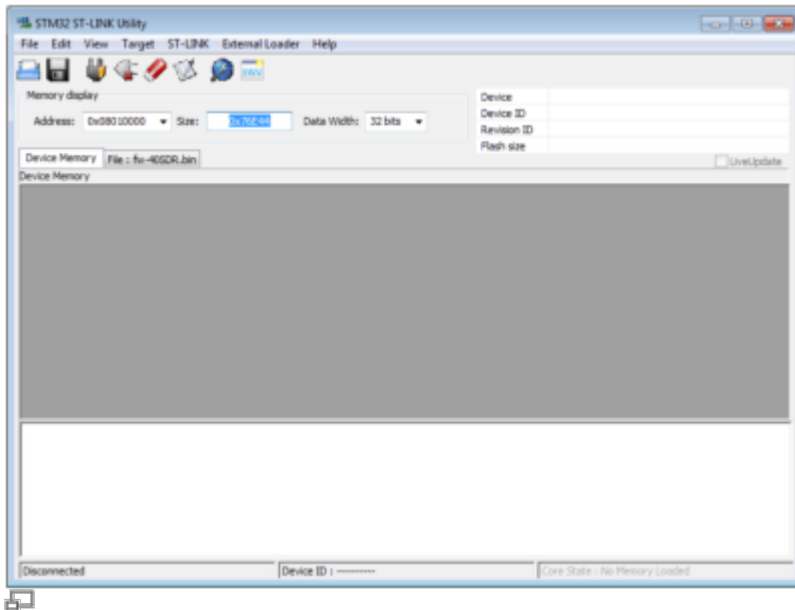
- Connect ST-Link/V2 with PC via USB cable
- SW Utility: ST-Link→Firmware update
- Check on PC screen in status messages that MCU is recognized correctly

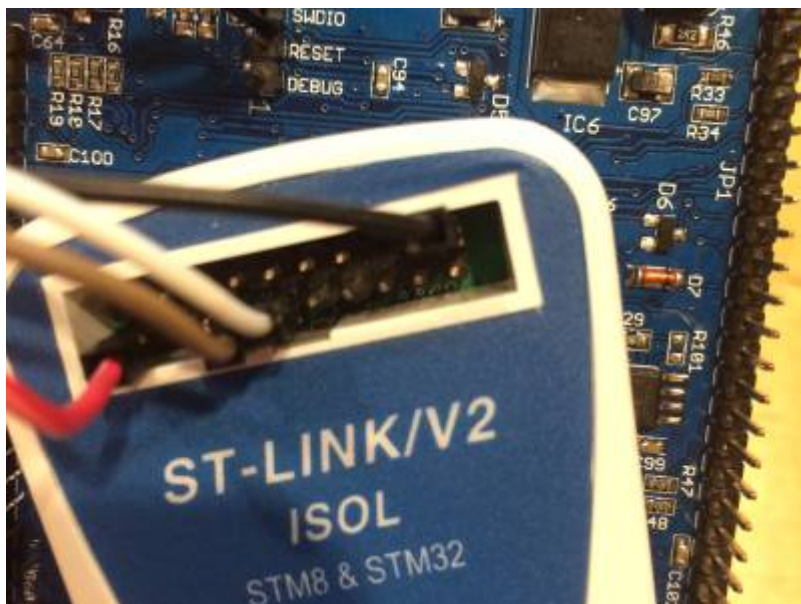
ST-link adapter	OVI40 UI JP8
Pin-9 SWCLK	JP8 Pin 4
Pin-7 SWDIO	JP8 Pin 3
Pin-20 Gnd	JP8 Pin 6
not essential: Signal: Reset	JP8 Pin 2

Connection ST-Link to UI board (photo F4HTX)

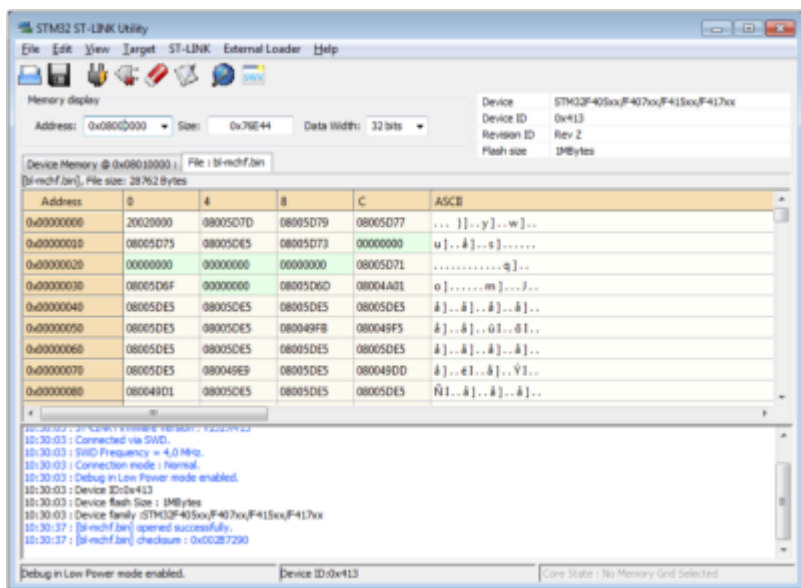
- SW Utility: Target→Connect
- SW Utility: File → Open (select the right .bin file, see above). The following screen should appear: (example shows mchF boot loader)

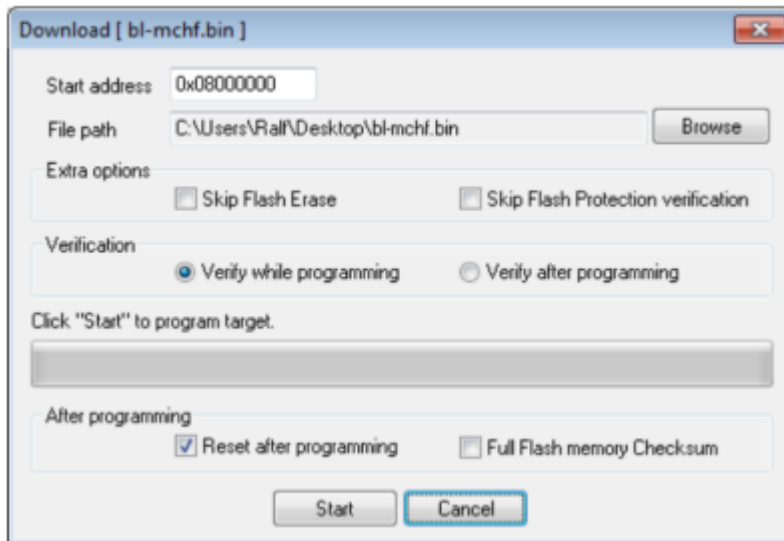
- Write the .bin file onto MCU with Target → Program & Verify
- In the subsequent window enter start address:
 - start address for boot loader: 0x08000000
- Then hit start button to program MCU

Für den Bootloader: 0x08000000

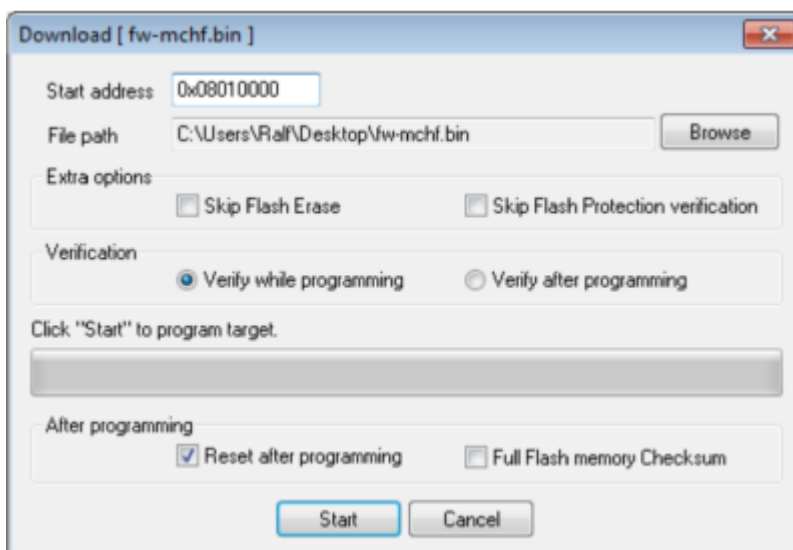
- Then program firmware in the same manner.
 - start address for firm ware would be 0x08010000
