UHSDR Troubleshooting

LCD constant white screen

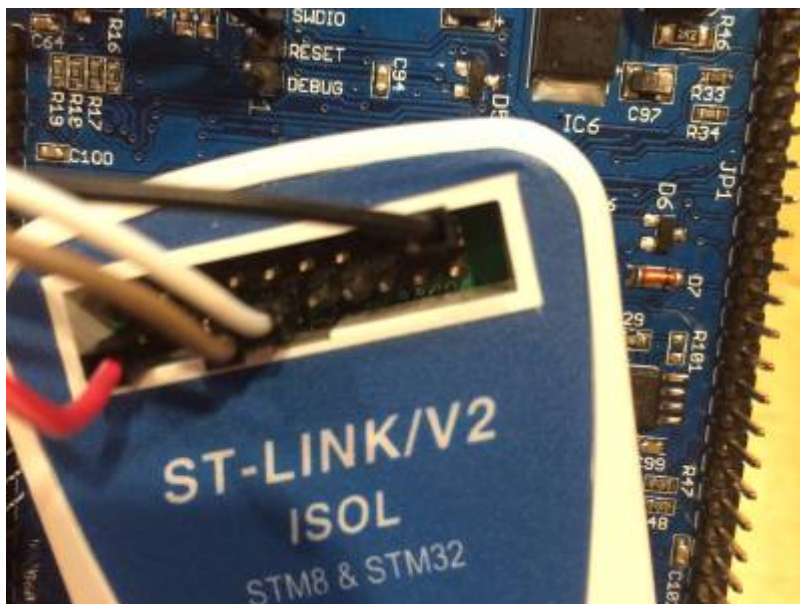
ST-link adapter	OVI40 UI JP8
Pin-9 SWCLK	JP8 Pin 4
Pin-7 SWDIO	JP8 Pin 3
Pin-20 Gnd	JP8 Pin 6
not essential: Signal: Reset	JP8 Pin 2

Connection ST-Link to UI board (photo F4HTX)

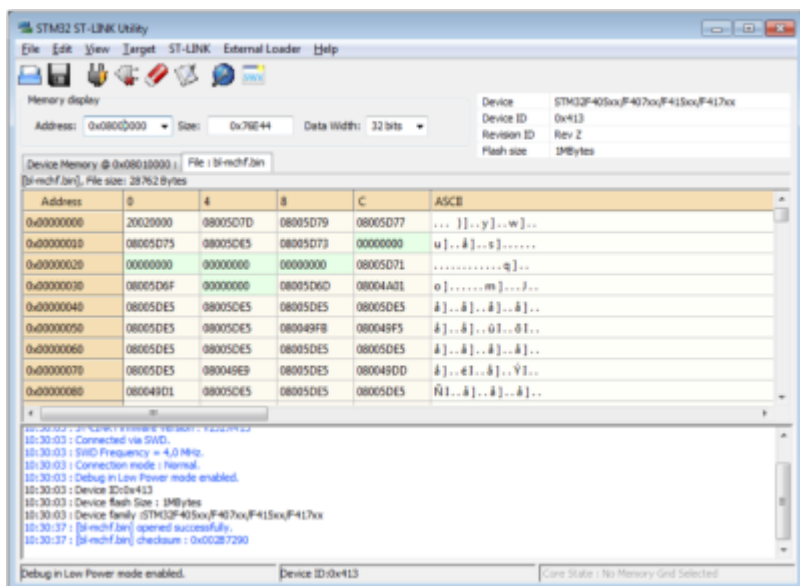
- SW Utility: Target→Connect
- SW Utility: File → Open (select the right .bin file, see above). The following screen should appear: (example shows mchF boot loader)

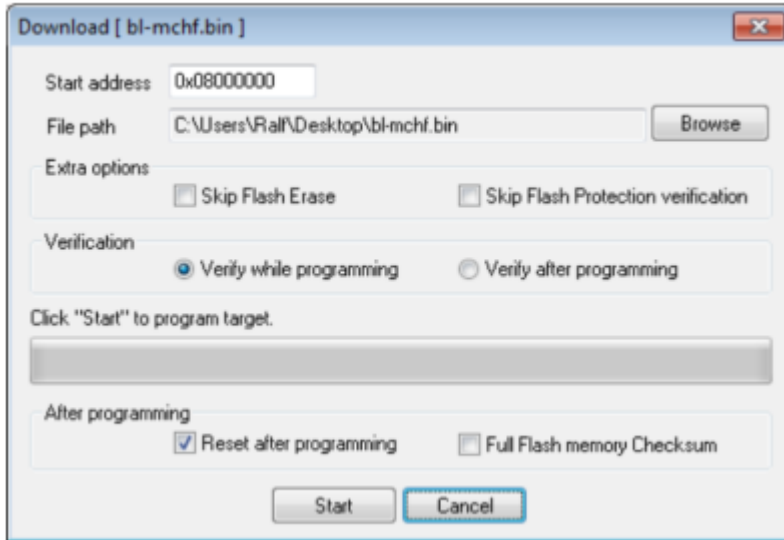
- Write the .bin file onto MCU with Target → Program & Verify
- In the subsequent windo enter start address:
 - start adresse for boot loader: 0x08000000
- Then hit start button to program MCU

Für den Bootloader: 0x08000000

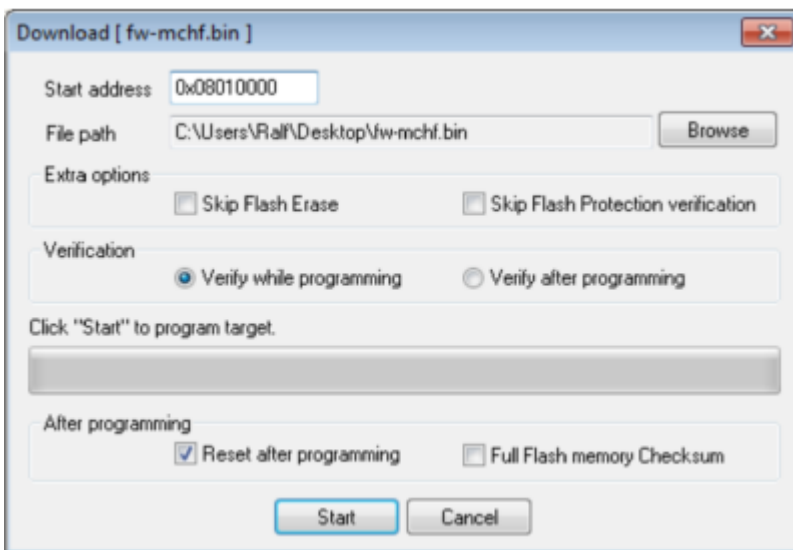
- Then program firmware in the same manner.
 - start address for firm ware would be 0x08010000
