UHSDR Troubleshooting

In case ST-Link/V2 available

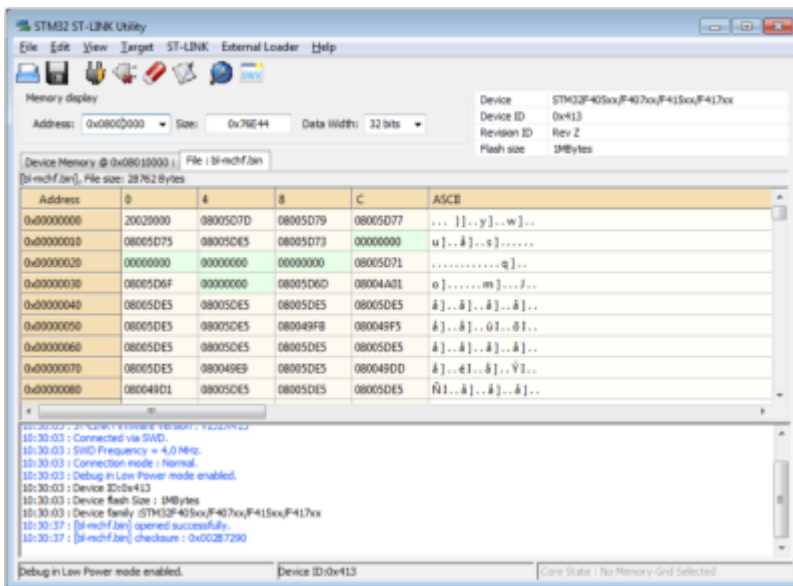
- SW Utility: Target→Connect
- SW Utility: File → Open (select the right .bin file, see above). The following screen should appear: (example shows mchF boot loader)
