UHSDR Troubleshooting

MCU "bricked"

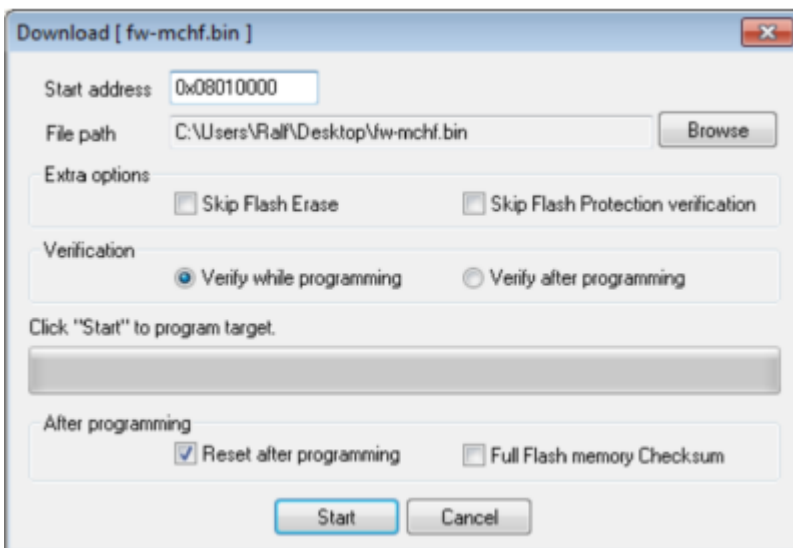
- Then program firmware in the same manner.
 - start address for firm ware would be 0x08010000
