UHSDR Troubleshooting

MCU "bricked"

In case ST-Link/V2 available

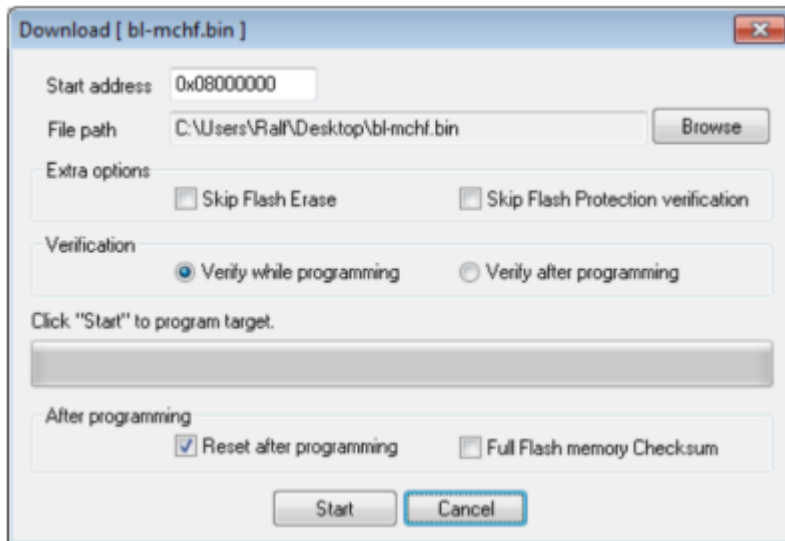
- Write the .bin file onto MCU with Target → Program & Verify
- In the subsequent window enter start address:
 - start address for boot loader: 0x08000000
- Then hit start button to program MCU

Für den Bootloader: 0x08000000

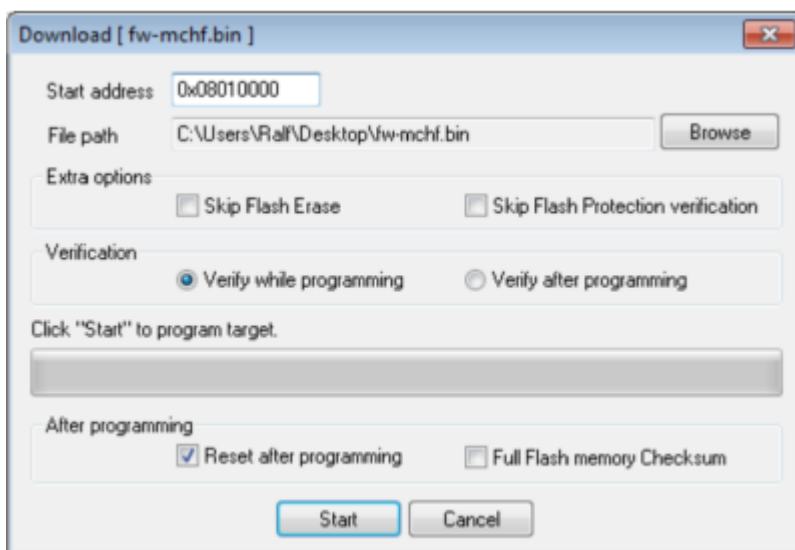
- Then program firmware in the same manner.
 - start address for firm ware would be 0x08010000
