UI Board Test & Fehlersuche

From: <https://amateurfunk-sulingen.de/wiki/> - Afu - Wiki des DARC OV Sulingen I40

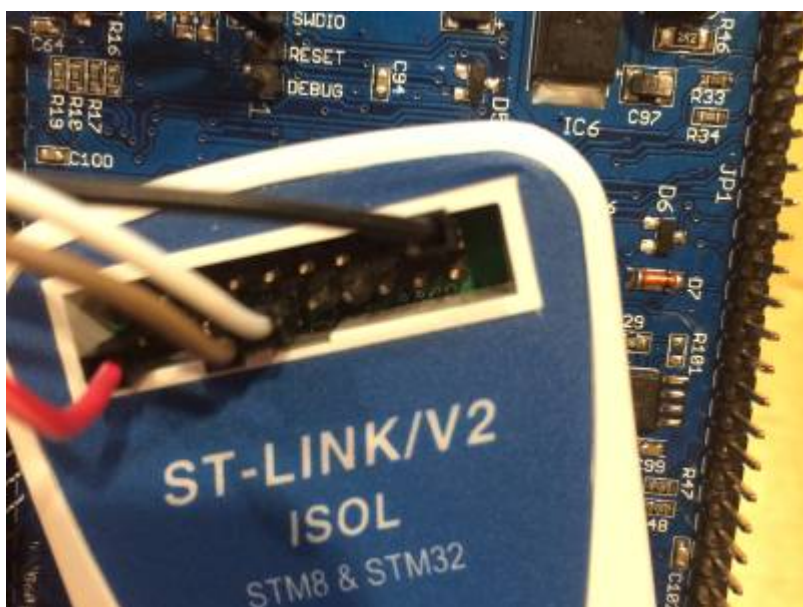
The only tricky part is to connect the probe JTAP connector to the JP8 UI board, here are the needed wires :

JP8-3 (SWDIO) to JTAG-7 JP8-4 (SWCLK) to JTAG-9 JP8-5 (UI_3V3) to JTAG-1 JP8-6 (GND) to JTAG-20

ST-Link connection to UI board (Photo F4HTX)

The rest of the procedure is straight forward : connect, erase, flash and you are done.

One additional trick, when I first connected to the MCU, I got an error message « Readout Protection Mode » and was unable to erase the chip. I finally choosed to try to flash a first time and the utility did what was necessary to remove the protection mode. Cool, thank you STM !
